Phase I Update to the Master Plan For Redevelopment of The Historic Quad

Central State Hospital Master Redevelopment Plan

Johnson Quinn and Associates

September 18, 2013

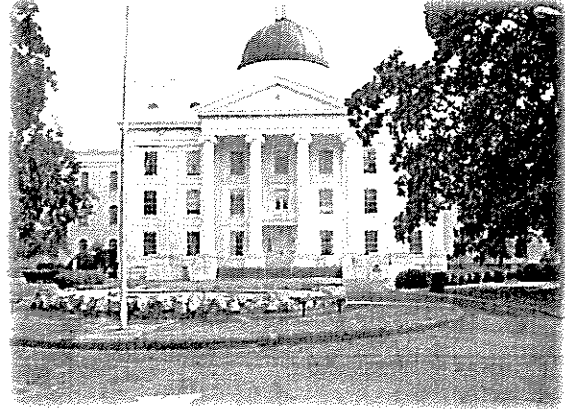
POWELL BUILDING

1. Building Construction: The overall building appears to have good structural integrity. We were unable to observe the type of building construction as Plant Operations was unsuccessful in locating the original drawings for the building. They will continue their attempts to locate these drawings.

2. Building Exterior: The exterior façades are in good condition. The building exterior walls should be repainted, including wall preparation, exterior sealant work and window evaluation for air and water infiltration.

3. Building Interior: Rooms and spaces on all levels appear to be serviceable. The interior walls and finishes appear to be in good condition. There is a small amount of water damage evident to the acoustical ceiling on the third floor level. This may be due to an air-conditioning unit condensate leak or blockage.

The front parking lot and fountain area should be repaired and properly maintained.

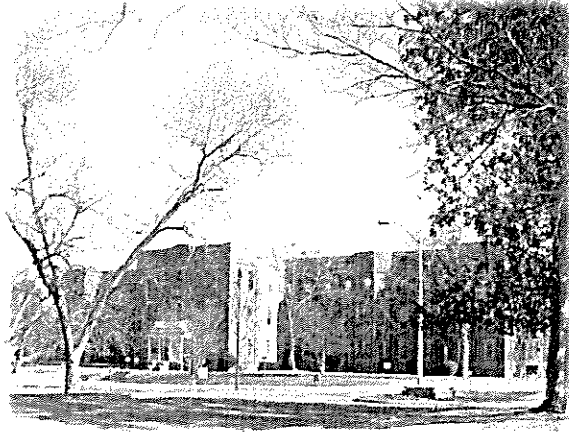
WALKER BUILDING

2. Building Exterior:
 - a. There is evidence of cracking of the brickwork at the eastside of the building.
 - b. There is patchy efflorescence (white calcium deposits) on random areas at the rear façade.

- c. There is evidence of missing brickwork at the building's parapet wall.
3. Building Interior:
 - a. The patient rooms, hallways, corridors, and stairwells reveal large quantities of peeling and flaking of lead based paint on walls and ceilings.

- b. Interior doors and frames reveal evidence of extreme rusting and scaling.
 - c. Broken windows are evident throughout the building.

4. Floor System: The structural integrity of the floor and vertical columns appears to be in good condition (main structural frame and floor diaphragms.) There is evidence of exposed reinforcement in a small number of the inverted concrete beams. This does not appear to adversely affect the main wind force resisting system of the building, but should be evaluated by a structural engineer.

5. Roof System: The wood roof system indicates clear evidence of damage, loss of structural integrity and overall failure. This structural failure is evident primarily at the front of the building. There is limited, or no, connection of the roof diaphragm to the front parapet wall.

The Walker Building is not habitable in its current state. The roof structure is undergoing failure due to the roof being open to the elements. The grounds should be fenced to prevent injury to the general public.

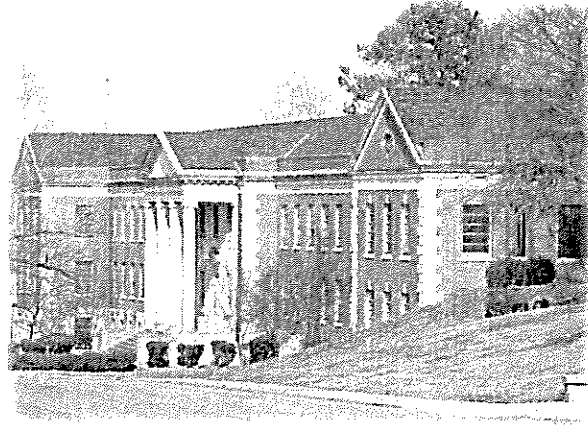
GREEN BUILDING

2. Building Exterior:
 - a. There is evidence of cracking of the brickwork at random locations on the building.
 - b. There is patchy efflorescence (white calcium deposits) on random areas at the rear façade.

- c. There is evidence of missing brickwork at the building's parapet wall.
3. Building Interior:
 - a. The patient rooms, hallways, corridors, and stairwells reveal large quantities of peeling and flaking of lead based paint on walls and ceilings.

- b. Interior doors and frames reveal evidence of extreme rusting and scaling.
 - c. Broken windows are evident throughout the building.

4. Floor System: The structural integrity of the floor and vertical columns appear to be in good condition (main structural frame and floor diaphragms.) There is evidence of exposed reinforcement in a small number of the inverted concrete beams. This does not appear to adversely affect the main wind force resisting system of the building, but should be evaluated by a structural engineer.
5. Roof System: The roof system appears to be structurally intact. The roofing condition is unknown.
6. Mechanical System: The mechanical systems are non-functional and non-operational.
7. Accessibility: Accessibility is non-conforming.

The Green Building is not habitable in its current state. The building should be inspected periodically to monitor for deterioration due to lack of use. Fencing the grounds, to prevent injury to the general public, should be considered. The lead based paint and broken windows are serious hazards.

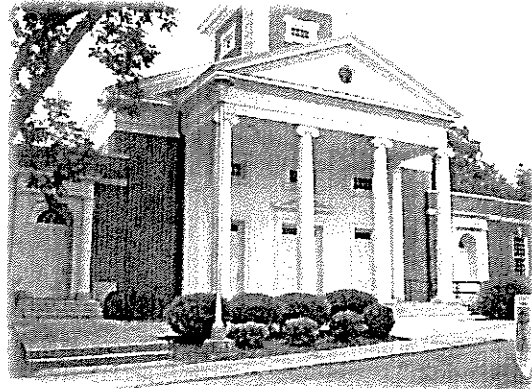
CENTRAL CHAPEL - NUMBER 1

Central Chapel – Number 1 currently serves as a multi-purpose chapel. The building functions well and appears to have been well maintained and is in good condition.

- 4. Floor System: The floor system appears to be structurally intact.
- 5. Roof System: The roof appears to be in good condition.
- 6. Mechanical System: The mechanical system appears to be in good condition.
- 7. Accessibility: Accessibility within the building is partially conforming. The existing accessible parking is non-conforming and should be corrected to ADA requirements.

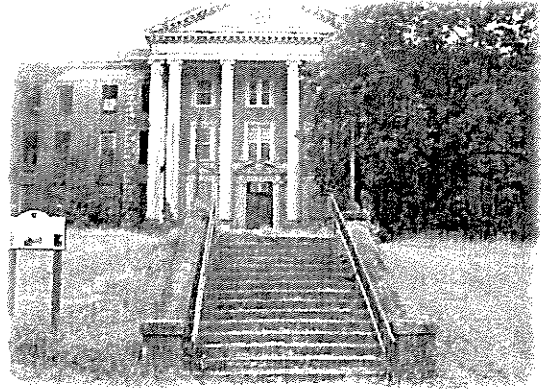
JONES BUILDING

2. Building Exterior:
 - a. There is evidence of cracking of the brickwork at random locations on the building.
 - b. There is patchy efflorescence (white calcium deposits) on random areas at the rear façade.

- c. There is evidence of missing brickwork at the building's parapet wall.
3. Building Interior:
 - a. The patient rooms, hallways, corridors, and stairwells reveal large quantities of peeling and flaking of lead based paint on walls and ceilings.

- b. Interior doors and frames reveal evidence of extreme rusting and scaling.
 - c. Broken windows are evident throughout the building.

4. Floor System: The structural integrity of the floor and vertical columns appear to be in good condition (main structural frame and floor diaphragms.) There is evidence of exposed reinforcement in a small number of the inverted concrete beams. This does not appear to adversely affect the main wind force resisting system of the building, but should be evaluated by a structural engineer.
5. Roof System: The roof system appears to be damaged at the southeast end. The extent of damage should be evaluated.
6. Mechanical System: The mechanical systems are non-functional and non-operational.
7. Accessibility: Accessibility is non-conforming.

The Jones Building is not habitable in its current state. The building should be inspected periodically to monitor for deterioration due to lack of use. Fencing the grounds, to prevent injury to the general public, should be considered. The lead based paint and broken windows are serious hazards.

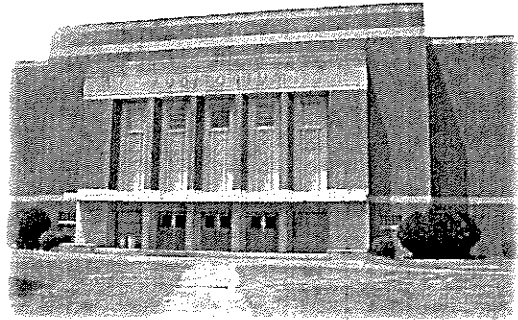
AUDITORIUM

2. Building Exterior: The building exterior appears to be in good condition. There is evidence of possible water damage to the brickwork at the right side of the entrance adjacent to the art deco vertical brick columns.

3. Building Interior:
 - a. The gymnasium wood floor appears to be worn down and patched in some areas. Our recommendation would be to sand the existing floor and refinish it with a sport grade urethane. There is evidence of flaking and peeling of lead based paint in the stairwells and changing rooms on the second level. There is excessive displacement of plaster ceiling in the old changing room areas. This is possibly due to roof water damage.

The unsafe conditions present in the Auditorium are primarily associated with the changing rooms. These areas should be tested for hazardous materials and abated as required. The lead based paint is a serious hazard.

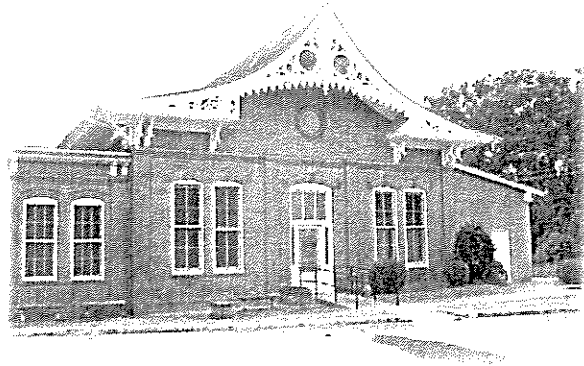
1. Building Construction: The building appears to be in good condition.
2. Building Exterior: The exterior brickwork on the north side of the building appears to be in reasonably good condition. There is evidence of damage to the brickwork and loss of mortar in areas above the Loading Dock at the west side of the building. There appears to be no water proofing at the Loading Dock floor.

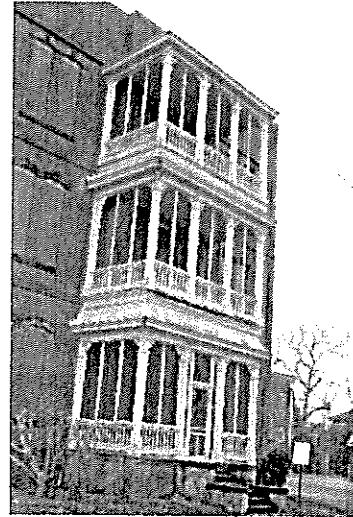
WALKER BUILDING - NUMBER 2

1. Building Construction: The building appears to be constructed of structural concrete columns and monolithic concrete floor system with inverted concrete beams above the bearing walls. The exterior walls are constructed with unit masonry, clad with decorative brick veneer. The roof framing system appears to be of heavy timber construction.
2. Building Exterior:
 - a. There is evidence of cracking of the brickwork.
 - b. There is patchy efflorescence (white calcium deposits) on random areas at the rear façade.
 - c. There is evidence of missing brickwork at various locations.
 - d. Wood trim is in need of restoration.
3. Building Interior:
 - a. The rooms, hallways, corridors, and stairwells reveal quantities of peeling and flaking of lead based paint on walls and ceilings.
 - b. Interior doors and frames reveal evidence of extreme rusting and scaling.
 - c. Window condition is poor.

4. Floor System: The structural integrity of the floor and vertical columns appears to be in good condition (main structural frame and floor diaphragms).
5. Roof System: The wood roof system indicates clear evidence of damage, loss of structural integrity and overall failure. This structural failure is evident primarily at the front of the building. There is limited, or no, connection of the roof diaphragm to the front parapet wall.
6. Mechanical System: The mechanical systems are non-functional and non-operational.
7. Accessibility: This building is not habitable and has been spared condemnation because of its historic and architectural significance within the Historic Quad.

Our recommendation for the Walker Building – Number 2 is to renovate it as the new location of the Central State Hospital Museum. This could be achieved with a new Elevator and Lobby addition to the rear or northwest corner of the building. This re-purpose would preserve one of the oldest buildings on the campus and allow the Depot to begin generating income for the Redevelopment Authority.

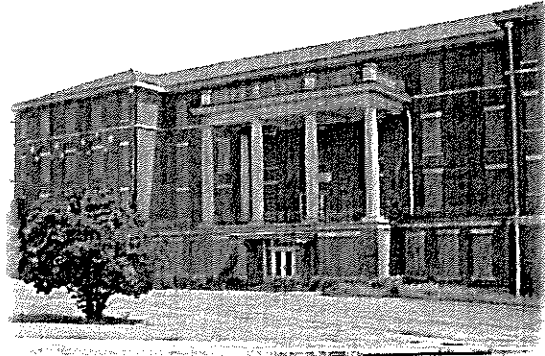
2. Building Exterior:
 - a. There is evidence of cracking of the brickwork at random locations on the building.
 - b. There is patchy efflorescence (white calcium deposits) on random areas at the rear façade.

- c. There is evidence of deterioration around the building's eave and windows.
 - d. A poor grading condition is apparent on the northwest corner of the building resulting in the bottom of the window being too close to grade.

- b. Interior doors and frames reveal evidence of rusting and scaling.
 - c. Window openings have been boarded up throughout the building.

4. Floor System: The structural integrity of the floor and vertical columns appear to be in good condition (main structural frame and floor diaphragms.) There is evidence of exposed reinforcement in a small number of the inverted concrete beams. This does not appear to adversely affect the main wind force resisting system of the building, but should be evaluated by a structural engineer.
5. Roof System: The roof is a clay tile roof that seems to be functioning properly according to CSH staff.
6. Mechanical System: The mechanical systems are non-functional and non-operational.
7. Accessibility: Accessibility is non-conforming.

The Brantley Building is not habitable in its current state. The building should be inspected periodically to monitor for deterioration due to lack of use. Fencing the grounds, to prevent injury to the general public, should be considered. The lead based paint and broken windows are serious hazards.
